Damage Behavior of Composite
Structures and Joints
at Room and Elevated Temperatures

Final Report: Phase I

Contract No: DAAE07-96-C-X-121

March 1998

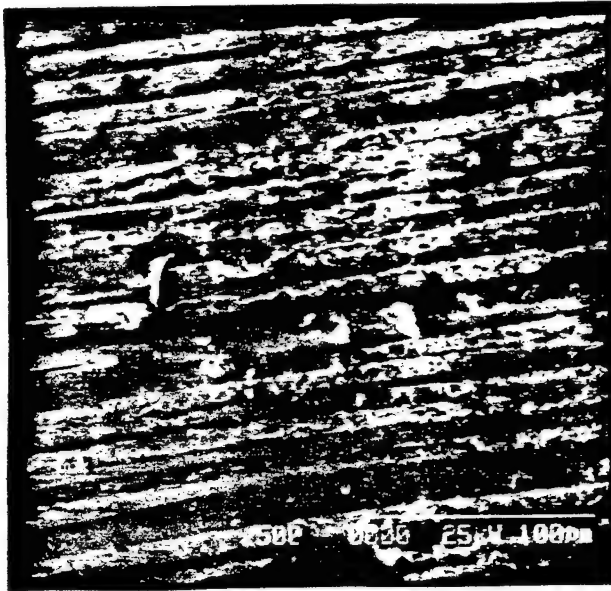
(a) No Load

(b) at 930 MPa

(c) At 1300 MPa

(d) at 1480 MPa
Fiber breakage

Fig.6 Microphotographs showing fiber breakage and interfacial debonding.
